PRINCETON UNIV N J DEPT OF ELECTRICAL ENGINEERING
THE INFLUENCE OF CONTACT AND INTERFACE EFFECTS OF THE ELECTRONI--ETC(U)
JUL 79 P MARK

FINAL TECHNICAL REPORT:

The Influence of Contact and Interface Effects
of the Electronic Properties and Stability
of Chemically Unstable Materials

SCANNING AUGER MICROSCOPY (SAM) STUDIES OF WORN BORE SURFACES*

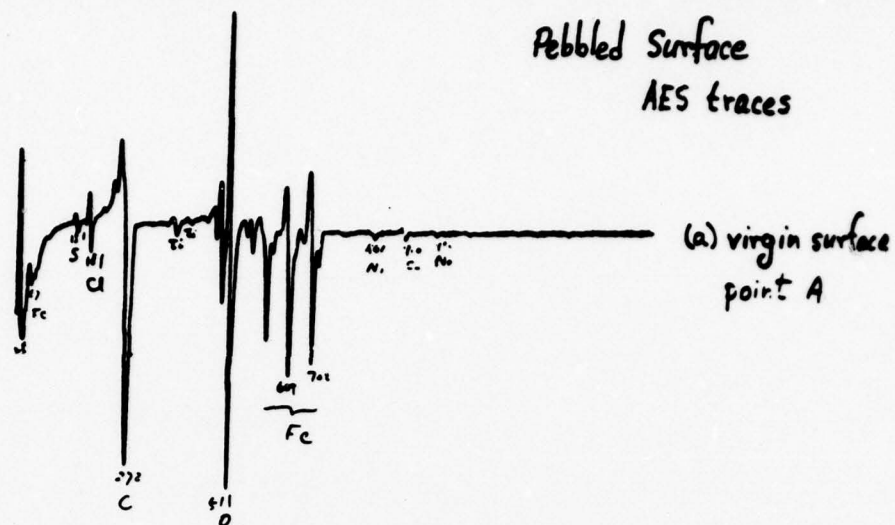
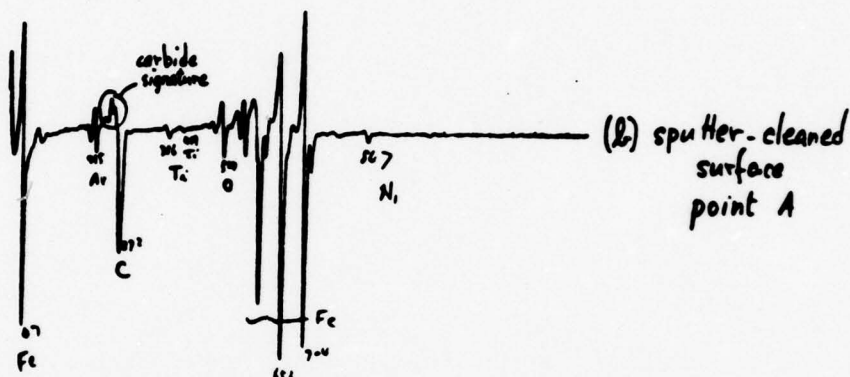
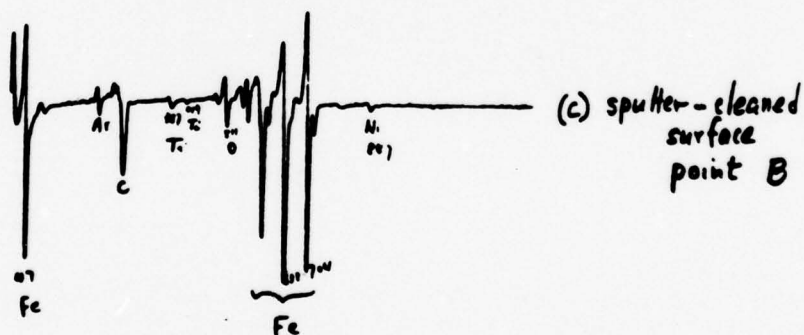
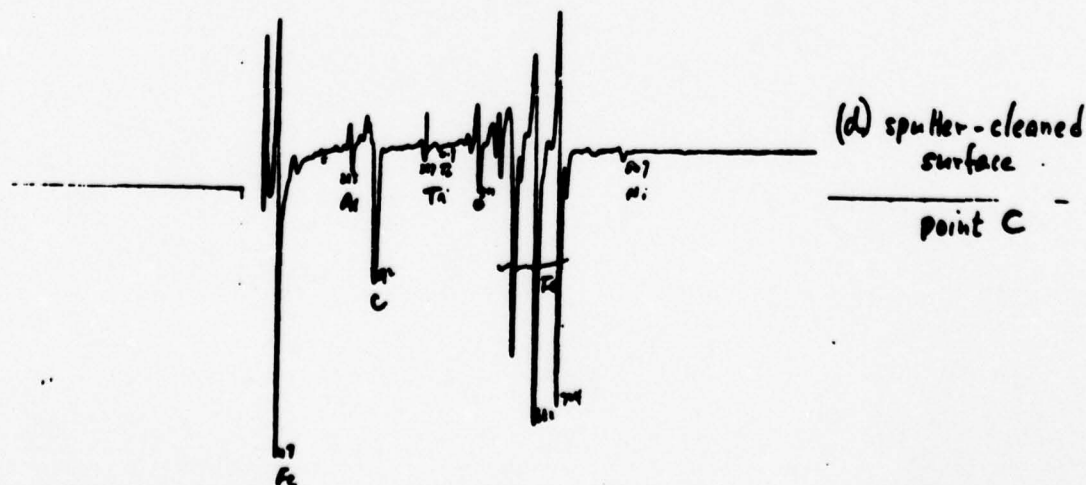
Figure 1

An Auger electron spectroscopy (AES) trace of a virgin pebbled surface (washed in methanol) is shown by trace a of Fig. 1. The predominance of carbon and oxygen signals is typical of any virgin surface. These elements represent the residues of organic surface contaminants that have been cracked by the 3kV primary electron beam of the CMA. The presence of chlorine and sulfur is also frequently observed on virgin surfaces as environmental contaminants. The small size of the low voltage (47V) iron signal is also evidence of a surface contamination coating. The escape depth of these low energy electrons is of the order of 7Å so that they are easily absorbed by very thin contamination layers. The small Ni and Cu signals are not unusual for a steel surface. The Na and Ti are unexplained at this point in the analysis.

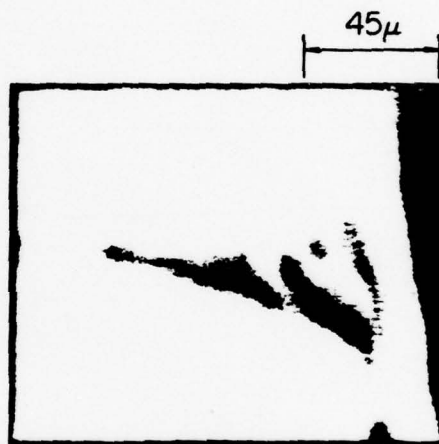
FIGURE 6

The photograph of Fig. 6, panel a, shows the low magnification SEM image of three cracks (labelled A, B and C) running into the bore surface. This is shown by the tapered dark images running from the wide ends at the pebbled surface to the left into the bore material. The surface containing the cracks was machine-cut. Fractured surfaces will be studied later. The AES traces a, b and c of Fig. 5 were recorded with the primary electron beam incident at the surface-end (wide-end) of cracks A, B and C, respectively.

Panel b of Fig. 6 is an SEM image of crack A at higher magnification. The remaining photographs are N-(c), Fe-(d), C-(e) and O-(f) SAM images of crack A. The photographs of Figs. 7 and 8 are similar analyses of cracks B and C, both arranged as follows. Panels a are SEM images. The remaining photographs are N-(panels b), Fe-(panels c), C-(panels d) and O-(panels e) images.

Although there are clear differences in the elemental distributions in these cracks, there are also some common features. For example, the C-images all show that carbon is distributed along the entire length of each crack. The C-signals of AES traces of Fig. 5 are clearly carbide signatures indicating that the carbon in the cracks are most likely metal carbides that have segregated there during the embrittlement of the steel. On the other hand, the N-images all show nitrogen distributions that tend to aggregate at the middle of each crack. The nitrogen is probably in the form of metal nitrides which were formed by reactions between the metal on the crack surfaces and the nitrogenous constituents of the hot propellant gases under pressure during the firings. The absence of nitrogen at the open end of the cracks can be attributed to competing reactions with oxygen to form volatile components. This is suggested by the fact that the O-images show the oxygen more or less concentrated at the open ends of the cracks, in part bonded to carbon (because of the partial correlation with the C-images) and in part as iron oxides because of the correlation with the iron images. No Ti was detected in the cracks. At this point in our work it is not clear why. It may have to do with the fact that the cracks were not clearly correlated with the austenitic grain boundaries of the pebbled surface.

From these preliminary examinations of the surface cracks, it is evident that propellant reactant constituents are non-uniformly distributed in the cracks and that some of the chemistry occurring at the crack surfaces with the propellant gases can be traced by SAM techniques. Laying the crack surfaces bare by low-temperature fracture will yield additional information about crack formation and chemical activity at crack surfaces.

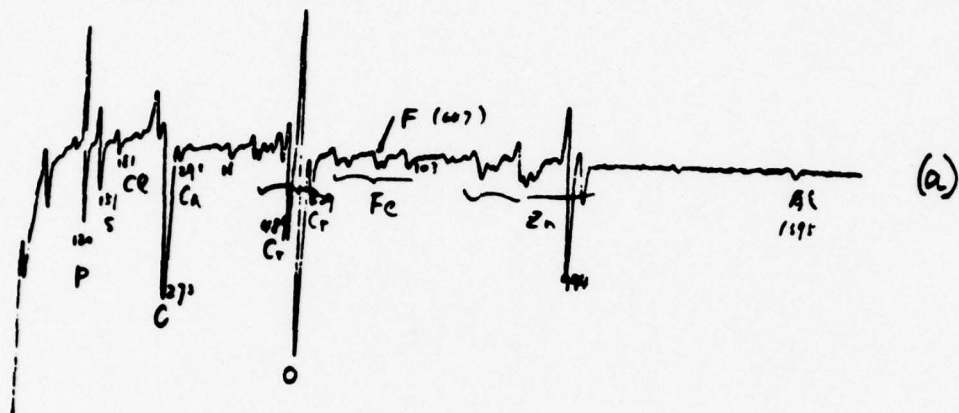
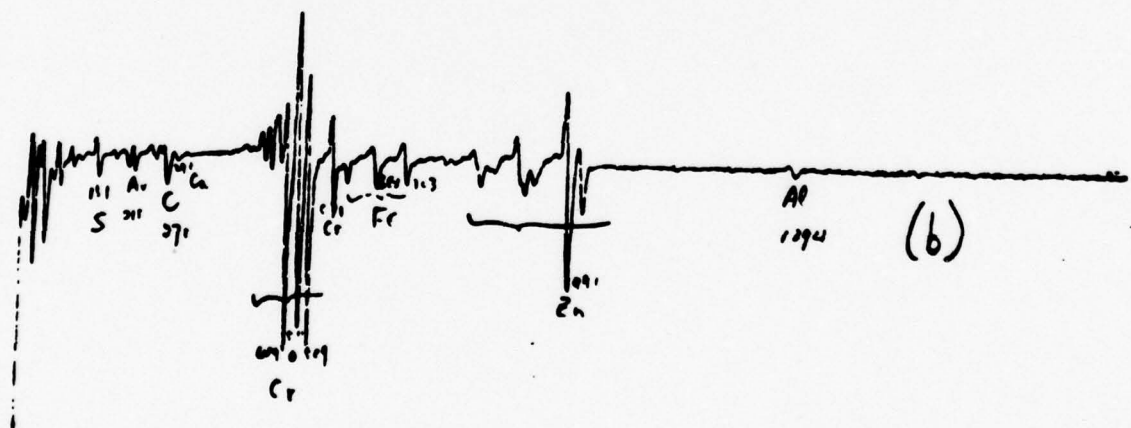
To resolve these issues, the surface of the specimen was scratched with a diamond scribe. Panel a of Fig. 13 is an SEM image of the scratch. The surface damage is clearly evident. The virgin-surface AES trace is trace a of Fig. 12. It shows the strong C- and O-signals typical of environmental surface contamination. Also, a strong Cr-signal is now evident, suggesting that the original Cr-coating may have been revealed by the scratch.

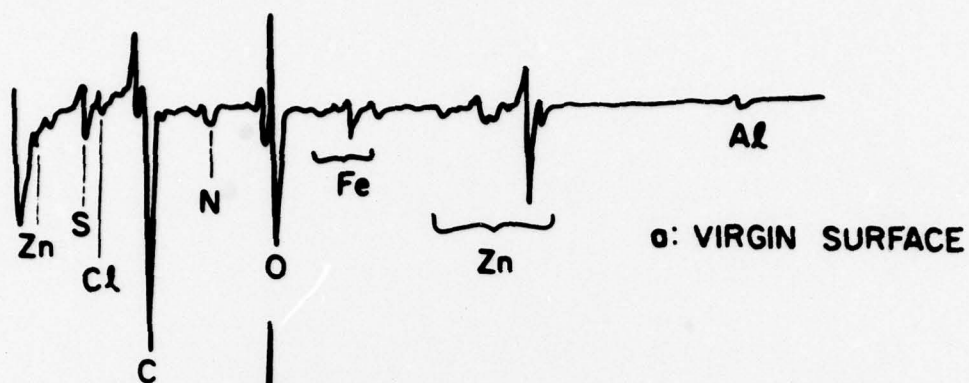
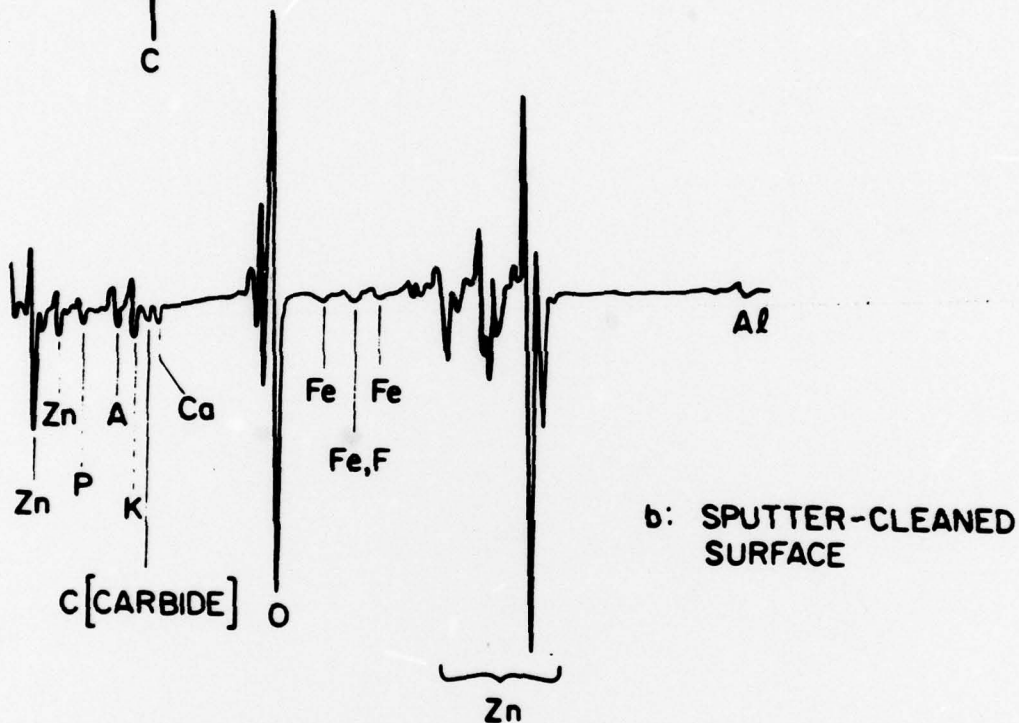
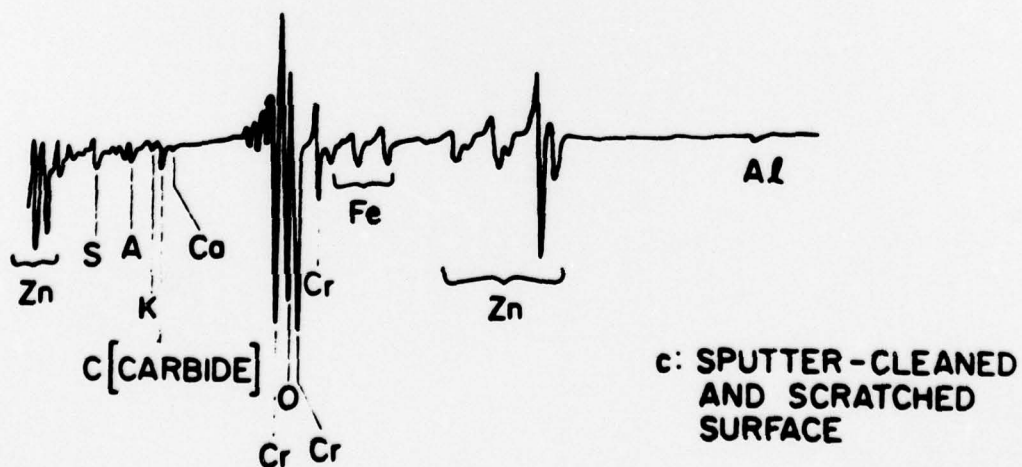
Trace a was obtained from the virgin surface, prior to sputter-cleaning. The trace shows several elements usually observed on any metallic surface that had been exposed to the atmosphere. These are C, O, N and Cl. Only a small amount of Fe and no Cr are present which may result from the presence of the surface contaminants. The large Zn signal cannot be attributed to atmospheric contamination.

from implanted sputtering ions. Also, the S and Cl signals of the virgin trace are gone indicating that these were atmospheric contaminants. The small Al signal of the virgin trace is still observed. Fifth, and perhaps most important, there is no evidence of Cr in trace b. This means either that the Cr-plating has been completely lost from the specimen surface through wear and erosion or that it is completely covered by a surface coating.

1. AES traces of Cr-plated 105 mm bore surface.

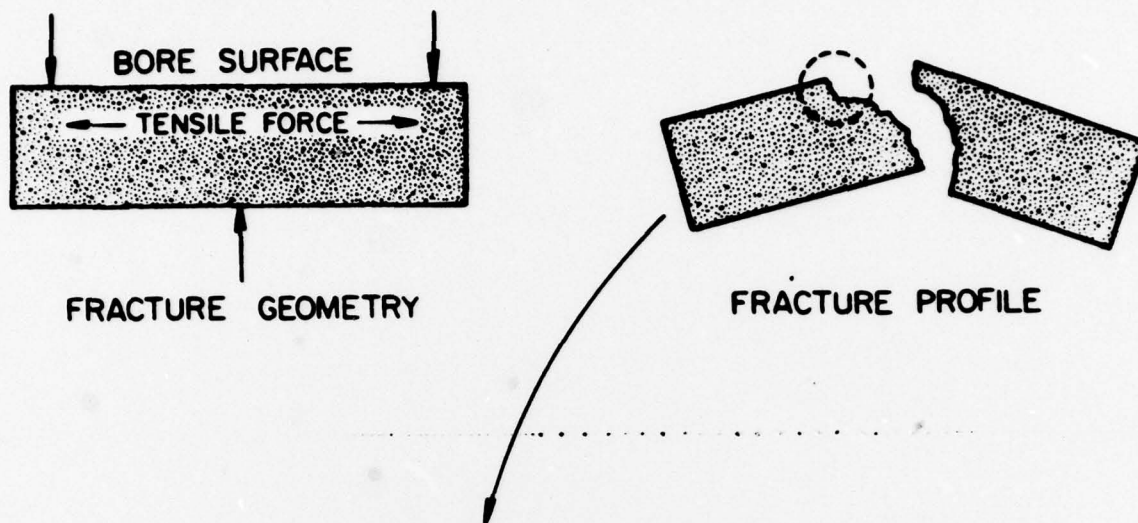
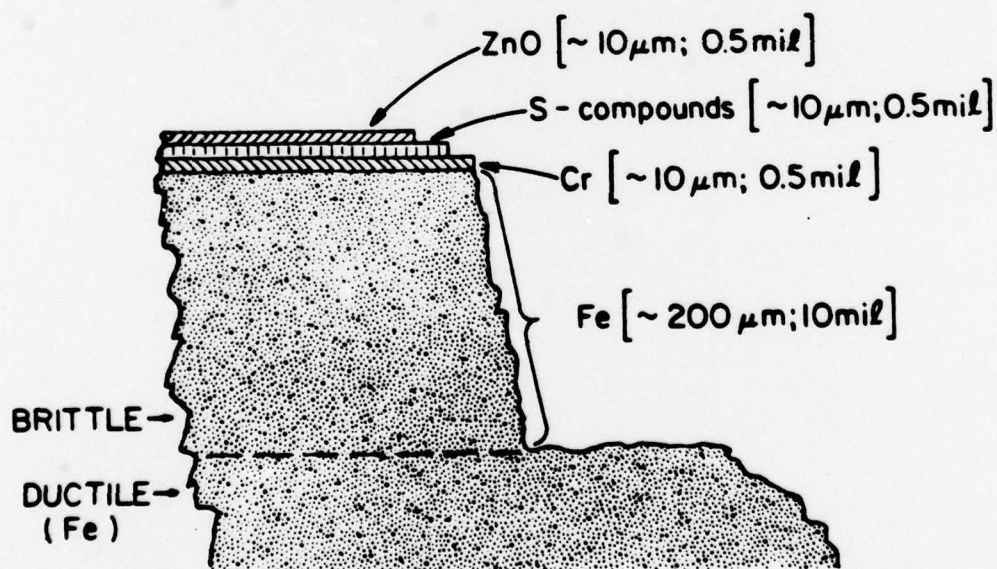
The geometry is illustrated schematically by the top, left panel of Fig. 6. The specimens were fractured with the force components shown in this panel which resulted in a tensile force parallel to the bore surface. The fracture profile observed with both specimens is shown schematically by the top, right panel of Fig. 6. An enlargement in the vicinity of the bore surface is shown schematically by the bottom panel and will be discussed below after the experimental information has been presented. At this point what is important is that both specimens had similar fracture profiles as illustrated by the top, right and bottom panels of Fig. 6. There is an "altered layer" about 200 μm deep whose fracture face was nearly perpendicular to the surface tensile force. This can also be seen from the optical micrographs of Fig. 7, which show the fracture surfaces of the Cr-plated specimen and of the unplated specimen in the top and bottom panels, respectively. Below the altered layer, the fracture face is nearly parallel to the tensile force for both specimens. This indicates that the altered layer is brittle and that the interface between the altered layer and the unaltered substrate cannot sustain a shear force. This same interface is parted when material is spalled from the bore surface.

6. Schematic sketches of fracture analysis.
